IMPACT DAMAGE CHARACTERIZATION OF SANDWICH PANELS PRODUCED WITH CORK AND PVC TYPES OF CORE

Key words: Impact damage, Sandwich panels, Cork, PVC Divinycell, Experimental tests.

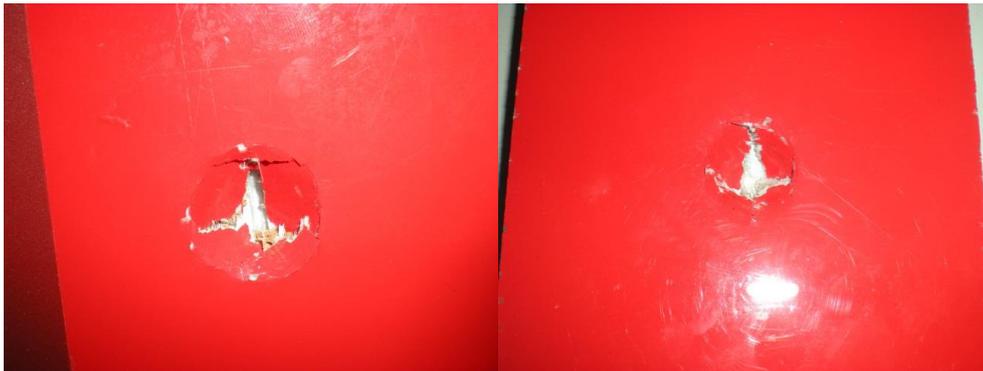
Figure 2 – Impact damage on the face subjected to impact NL10 Core (left) and Divinycell Core (right) at 100% Potential Energy

The damage on the upper faces is similar in both specimens with a circular indentation with penetration of the gel coating. The penetration of the impactor ruptures the glass fiber in a cruciform pattern coincident with the main orientation of the fibers. The indented area is similar for both types of specimens, a result expected since the penetrator entered fully into the specimen.

Figure 2 shows the impact damage occurred in upper faces due to 100% impact energy in the Cork core sandwich and the Divinycell core sandwich.

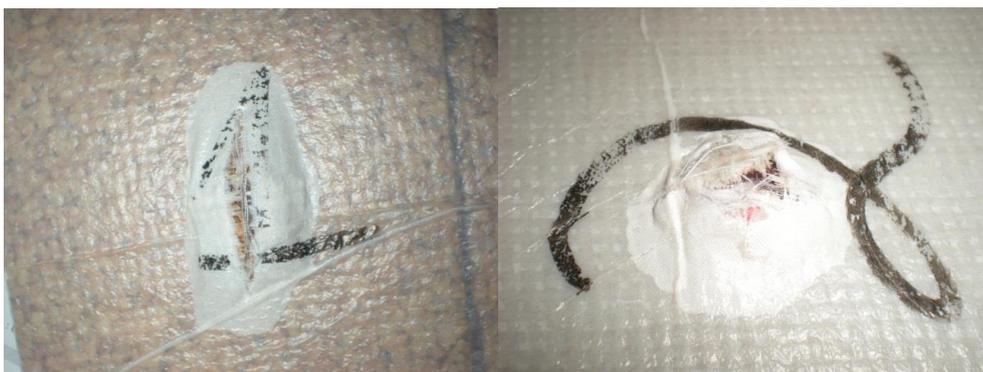
Figure 3 - Impact damage on the lower face NL10 Core (left) and Divinycell Core (right) at 100% Potential Energy

In the lower faces it can be seen a different behavior of the sandwich structure responses. In the Cork core the rupture takes a decidedly oval shape, while in the Divinycell cores the shape is circular. Analysis of both types of specimens seems to suggest that while the Divinycell cores compress and rupture, due to the high stress concentrations upon impact,

the NL10 Cores develop a crack in response to the stresses that propagates in one direction until the impactor passes through. This crack is formed along the Glass fiber plies and is dependent of the orientation, *i.e.*, the crack forms in either 0° or 90° depending on specimens, although its orientation is not dependent of the boundary conditions.

Figure 3 shows the impact damage occurred in lower faces due to 100% impact energy in the Cork core sandwich and the Divinycell core sandwich.

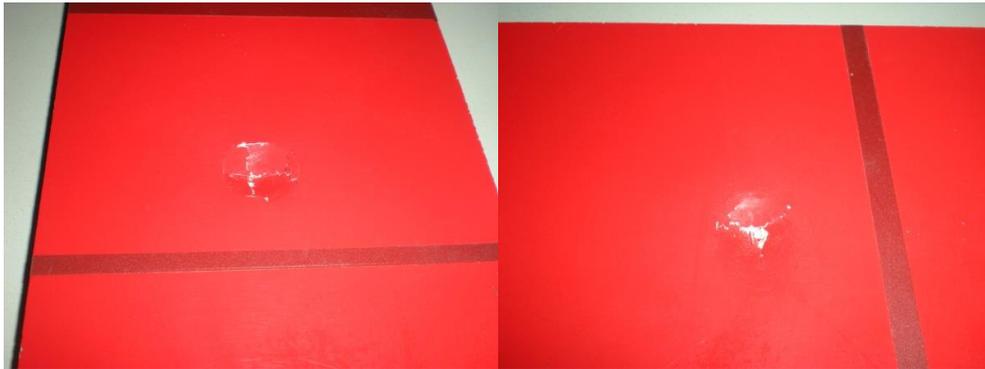
Figure 4 - Impact damage on the face subjected to impact NL10 Core (left) and Divinycell Core (right) at 50% Potential Energy

At 50% impact energy the damage in the upper face appears somewhat milder, although the impactor passed through the top face of the specimen. In both cores the damage of the upper face presents a similar pattern with a cruciform pattern of rupture appearing coincident with the glass fibers orientation.

Figure 4 shows the impact damage occurred in upper faces due to 50% potential energy in the Cork core sandwich and the Divinycell core sandwich.

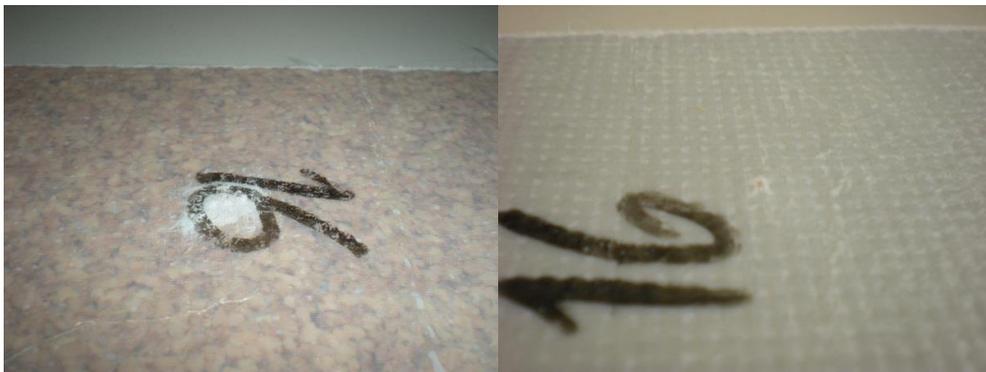
Figure 7 - Impact damage on the lower face NL10 Core (left) and Divinycell Core (right) at 33% Potential Energy

On the lower faces there is a significant difference in visible damage between cores. In most cork specimens there is visible damage to the lower faces, with facing damage in at least one layer of glass fiber, and some debonding. On the Divinycell cores there is little if any visible damage.

Figure 7 shows the impact damage occurred in lower faces due to 33% impact energy in the Cork core sandwich and the Divinycell core sandwich.
